# Public service vehicle (PSV) inspection manual

Helping you stay safe on Britain's roads

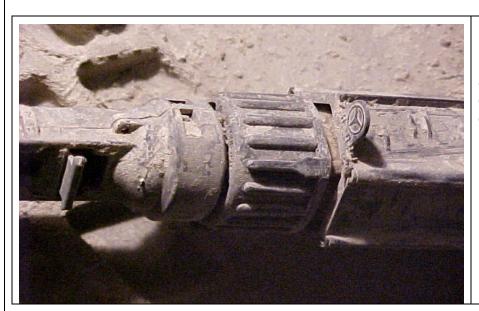
Plastic sleeve seals are acceptable but will require an embossed identification, (see example to left).
